**ENVIRONMENTAL ASSESSMENT  
PROPOSED OCEAN ACCESS**

**AIRPORT COVE - MALLACOOTA**

FEBRUARY 1999

**Shearwater Environmental Management**

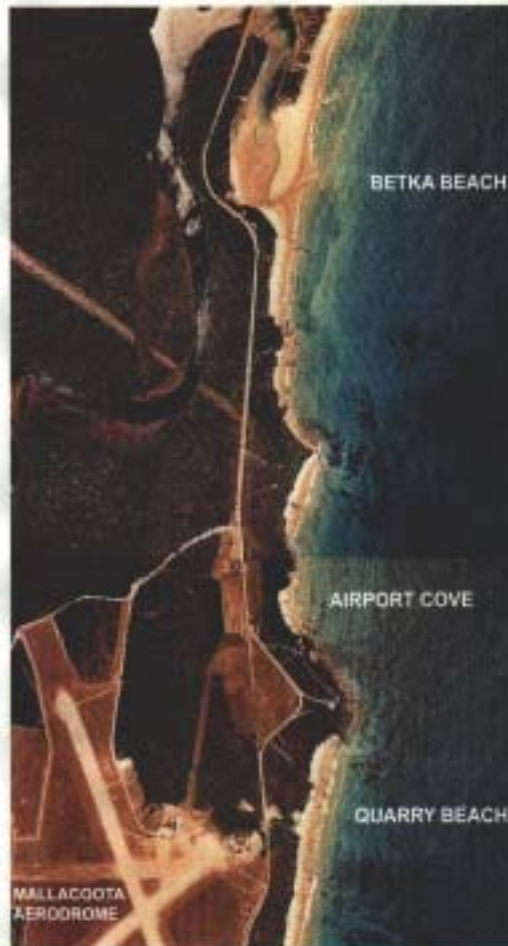
FIGURE 2 PHOTOMAP OF SITE

Airport Cove lies a little less than four kilometres south west of Bastion Point, Mallacoota and is opposite the northern end of the airfield (Figure 2). As there is sometimes confusion with place names that are not marked on topographic maps, the grid reference on the 1:50,000 map sheet is [8822-N, 8823-S (Part), MALLACOOTA, 410354].

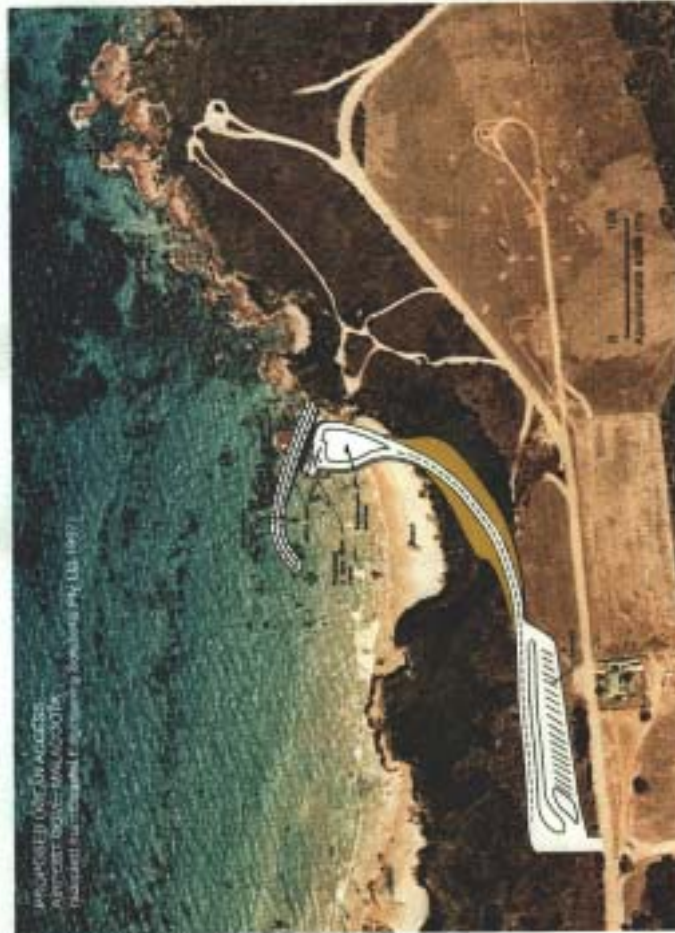
FIGURE 3 PROPOSED OCEAN ACCESS

The layout for an ocean access at Airport Cove has been adapted from the 1997 draft report from Coastal Engineering Solutions Pty.Ltd. (Figure 3). It is assumed that the schematic

Note that the yellow/brown areas on either side of the access road indicate the approximate location of the sides of the cutting.

drawings in that report are conceptual only and not the result of detailed investigations. Nevertheless, they give a good basis for the investigation of potential impacts. Any proposal for access to this cove would involve a car park, access road, cutting through the cliff, turning bay at the bottom, boat ramp, jetty and breakwater and we believe that small variations in design would not affect our overall assessment of impact.

For the purposes of this report, it is assumed that construction of an ocean access at Airport Cove will require a car park with a minimum capacity for 30 boat trailers and 20 cars. This would have dimensions of 180 metres by 40 metres. Provision would also have to be made for future expansion to accommodate an additional 30 boat trailers. A dual lane access road approximately eight metres wide would connect the carpark on the plateau, at a height of about 20 metres above sea level, to the boat ramp and would pass through the cliff line in the middle of the cove.

The gradient of this road would need to be no steeper than 1 in 10 to allow use by large and heavy boats. This means that the road needs to be about 200 metres long and that the downward grade would commence at the exit to the car park. The cutting would be approximately 10 metres deep and 30 metres wide before it reached the cliff line. As the cutting passes through the cliff line, the angle of the cliff and the angle of the walls of the cutting would mean that most of the vegetation above the cutting would be removed to the cliff edge and the area below the road would also need to be stabilised. These issues are discussed in Sections 2, 3 & 5.

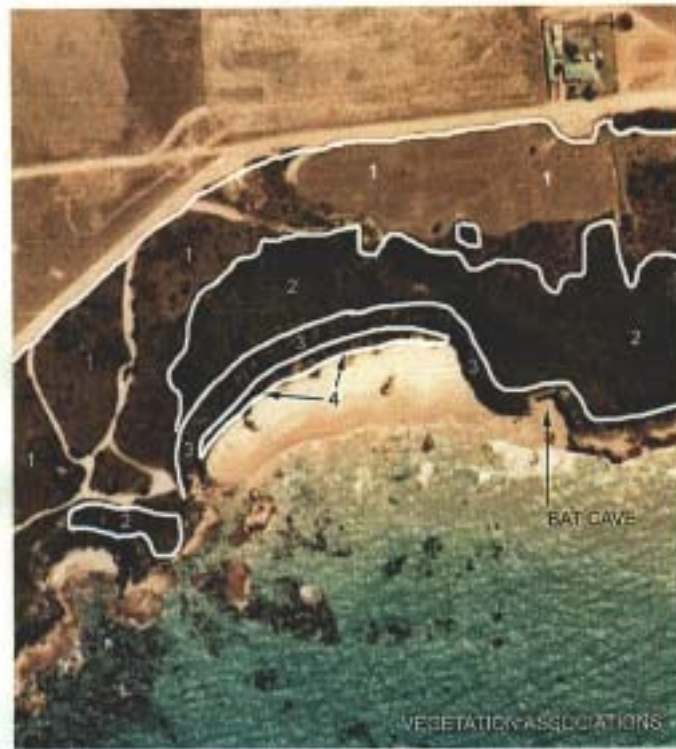
FIGURE 4 VEGETATION ASSOCIATIONS

The vegetation between the beach of Airport Cove and the Betka Rd consists of four, visually distinct associations, of varied width, parallel to the coast (Figure 4). An incomplete list of species observed in the associations is shown in Appendix 1. The classification of the four associations follows the description of Ecological Vegetation Classes (EVCs) for East Gippsland (Woodgate *et al.* 1994).

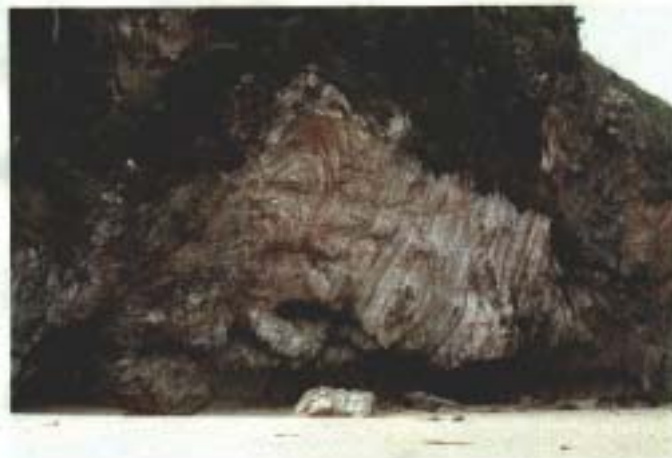
FIGURE 6 ROCK STRATA AT THE NORTHERN END OF THE COVE

As noted above, there is a tightly folded, sheared zone in the Ordovician rock, immediately behind the headland bluffs at each end of the beach (Figure 6). These have produced zones of rock with a higher degree of fracturing, and higher weathering than the more intact rock to either side.

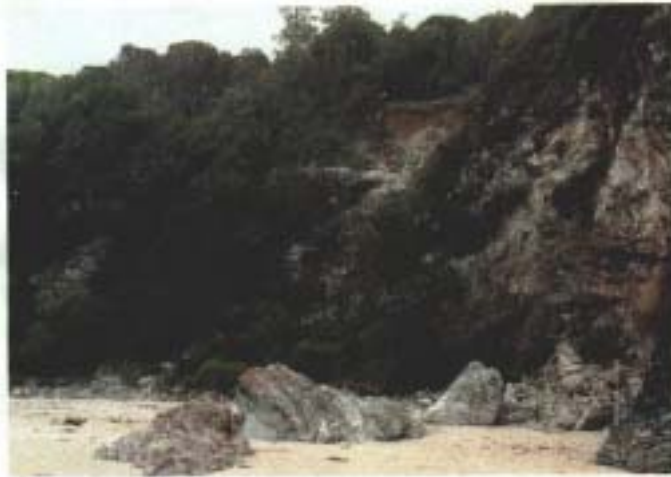
FIGURE 7 TOPSOIL SLIP AT NORTHERN END OF COVE

At the south end, a similar weakened zone occurs immediately above the proposed turning loop. In this area there is a small irregular slip, primarily caused by continued slumping of weathered Ordovician rock from near the top of the cliff. The mechanism at this point appears to comprise continual minor fretting of the face, and there is less apparent accumulated debris on the beach.

In both cases, the nature of the rock suggests that continuing instability can be expected.

Given the nature of the proposed facility at this site, and the configuration of the areas of instability, physical remediation of the slip areas is unlikely to be practicable.

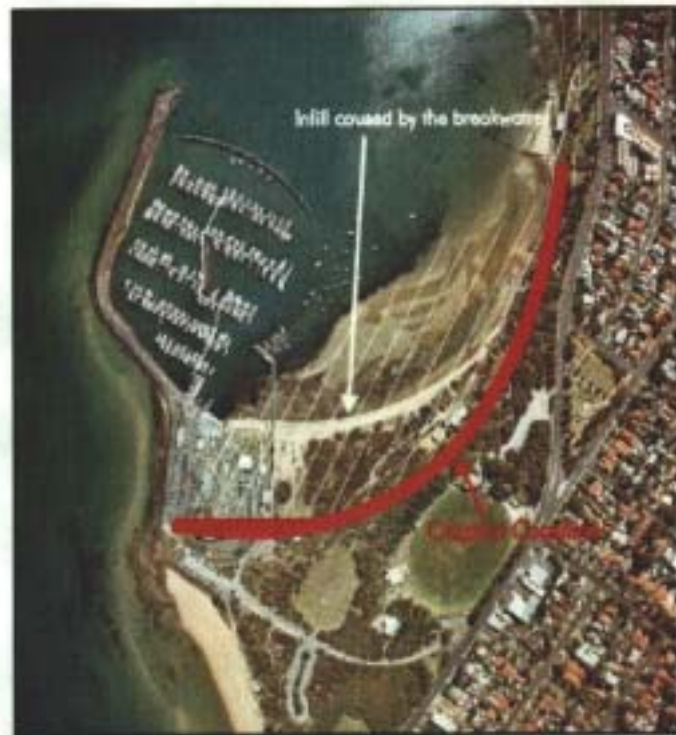
FIGURE 8 SANDRINGHAM HARBOUR

The significance of the above is that sand that is moving past the breakwater from further westward along the coast, will be caught behind the breakwater and will be realigned to the shape of the diffracted waves behind the breakwater. Once the sand is caught there is no mechanism for its removal and so the beach will build out. One of the best examples of this mechanism is the breakwater built after the second world war to create Sandringham harbour in Port Phillip Bay. Figure 8 shows the build up of sand in that harbour.

Field observations at low tide also indicated breaking waves with sand in suspension at the approximate position of the end of the proposed breakwater. This suggests that a breakwater would have to be longer to give adequate depth of water, but this would have to be confirmed by detailed soundings.

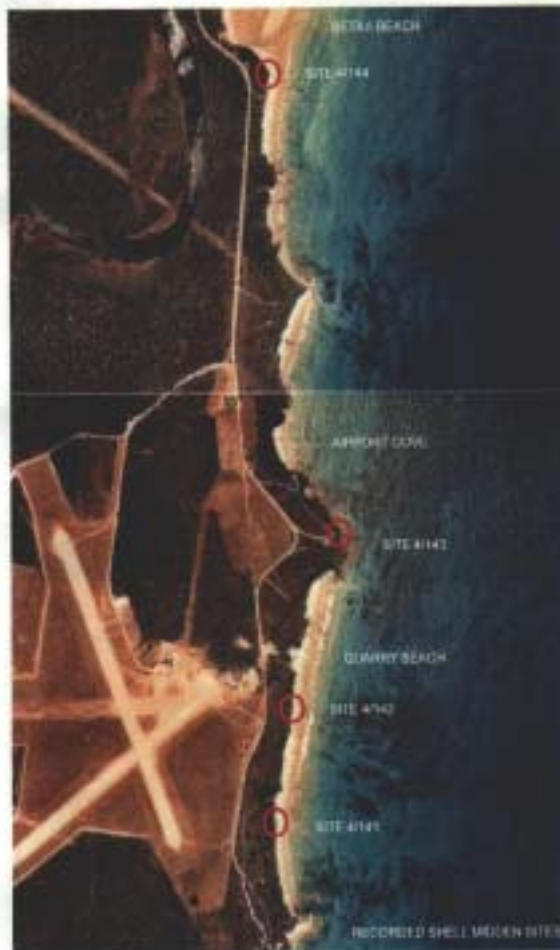
FIGURE 8 RECORDED MIDDEN SITES

Three sites are located near Airport Cove - two along Quarry Beach and the third on the headland to the south of Airport Cove. (Coultts et al, 1984, p. 3)(Figure 9). Site 88224/143 is described as a midden in very poor condition due to erosion, but with potential sub-surface deposits. The site was extensive, measuring 28 x 3 metres.(VAS Site Record 88224/143; Aboriginal Affairs Victoria, Heritage Services; Fullagar, 1984, p. 256) The site was located during a field visit on 14 February 1999 and it was found that deterioration due to erosion and foot traffic has been extensive.

- prior to any works being conducted at Airport Cove a full archeological survey of the area be conducted
- consultation occur with the Cultural officers and relevant community members of the local Koorie communities
- consultation occur with the Heritage Services, AAV with regard to an excavation being conducted on site 88224/143.
