**GIPPSLAND REGION  
PRELIMINARY SITE ASSESEMENT REPORT**

**PROPOSED BASTION POINT BOAT RAMP UPGRADE**

**FEBRUARY 2005**

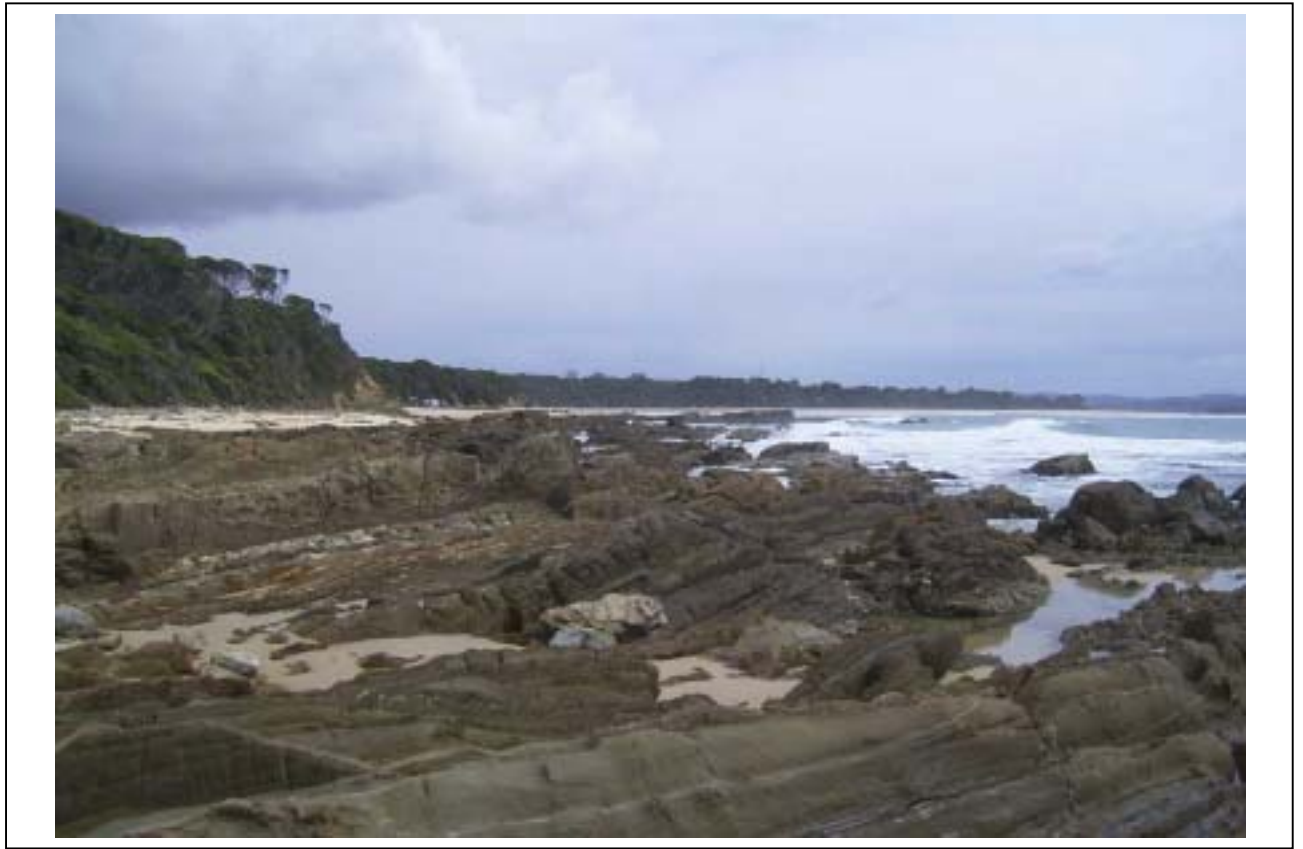
***Photo 1***  
***Existing conditions at Bastion Point***

Bastion Point is a relatively undisturbed location with the existing car park and roadway effectively screened from the beach by remnant patches of native vegetation. The current turning circle is located on an elevated area of beach and has a gravel surface that is topped by windblown sand. A section of this turning circle is utilised as car parking for boat trailers and a small car park (2 to 3 cars) is located on the northern corner of the site.

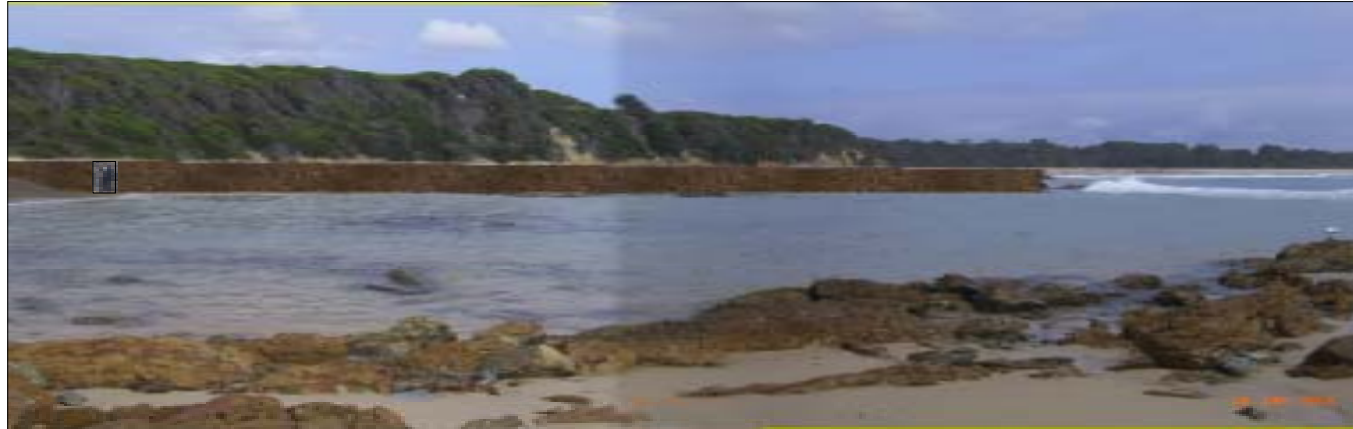
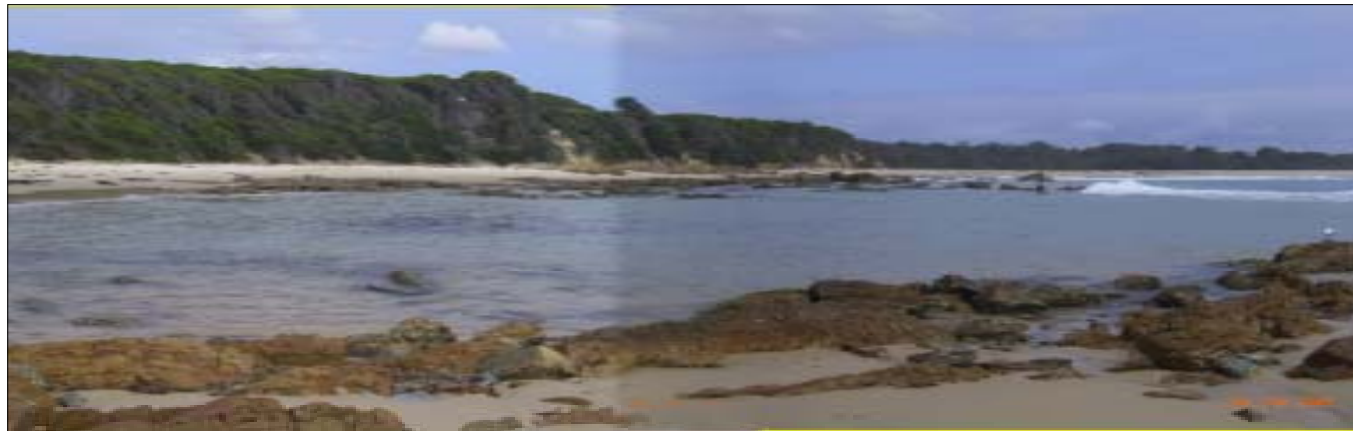
**Photo 3** (indicative only)

A second 2-metre high rock wall would also be required for Location 1 to prevent sand sweeping into the launch channel. This movement of sand is one of the major factors in limiting the effectiveness of the existing ramp at this location.

**SITE 1 - Potential visual impacts of a 2 metre break-wall at northern side of existing ramp**

2m high wall  
looking south

Existing Boat Ramp Area

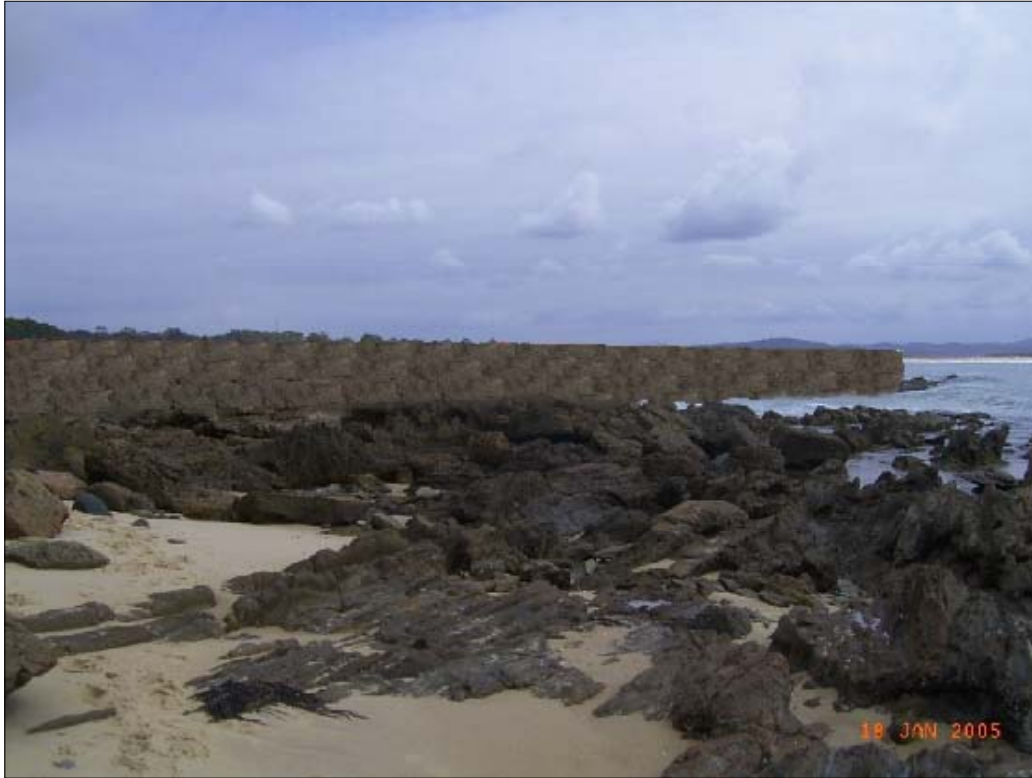
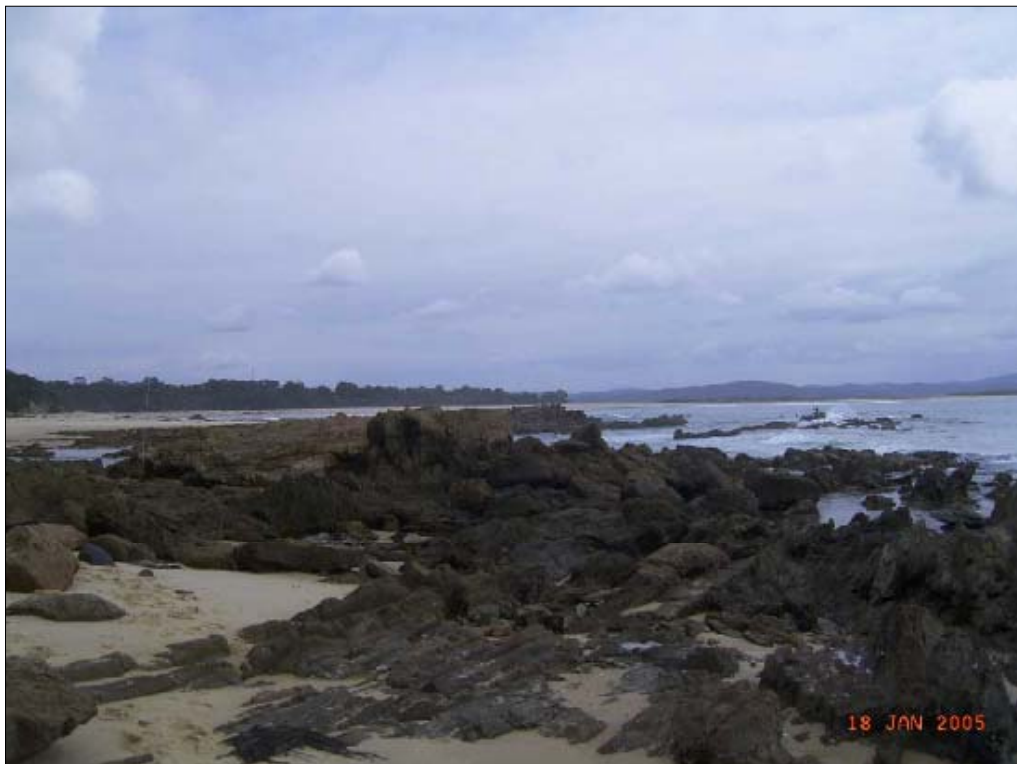
***Photo 4 (indicative only)***

The options presented following the completion of the Coastal Processes Study see the proposed introduction of break-walls varying between 2 to 3.5 metres high and up to 130 metres long. Limited details are provided in relation to the design of the proposed breakwaters and it is unclear if the walls need to be of a consistent height or whether the heights are peaks at specific locations.

***Site 3 - Potential visual impacts of a 3.5 metre break-wall looking towards existing ramp area***

Option 3 looking N
